NBSIR 73-167

Fire Endurance Test of a Roof/Ceiling Construction of Paper Honeycomb and Gypsum Board

Final Report

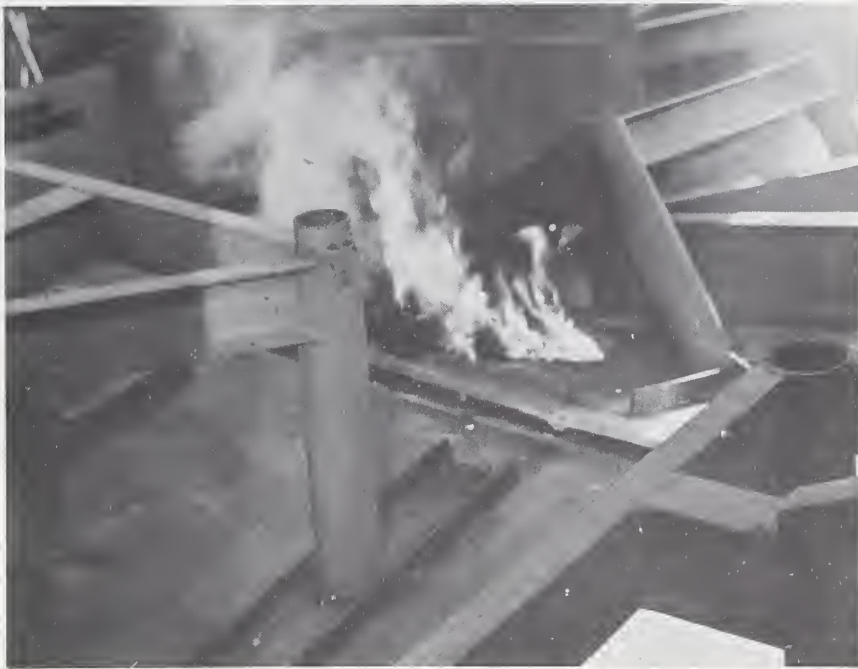
Figure 6. Flame through near center, with local load failure.

Failure occurred at an observed time of 37 min. 50 sec. by flame-through at the unexposed surface through a joint in the gypsum boards of one of the panels. A local load failure occurred about 10 sec. later at the site of the flame penetration.

Time-temperature curves for the thermocouples on the unexposed surface are shown in figure 4; those in the paper core, in figure 5. The flame-through failure and the inability to sustain the load at the failure point are illustrated in figure 6.

37:50	Flame-through occurring at the point where the gypsum board was failing under a loading point (see Figure 6).
38:00	Pieces of the upper layer of gypsum board at this loading point falling into the furnace (a local load failure).

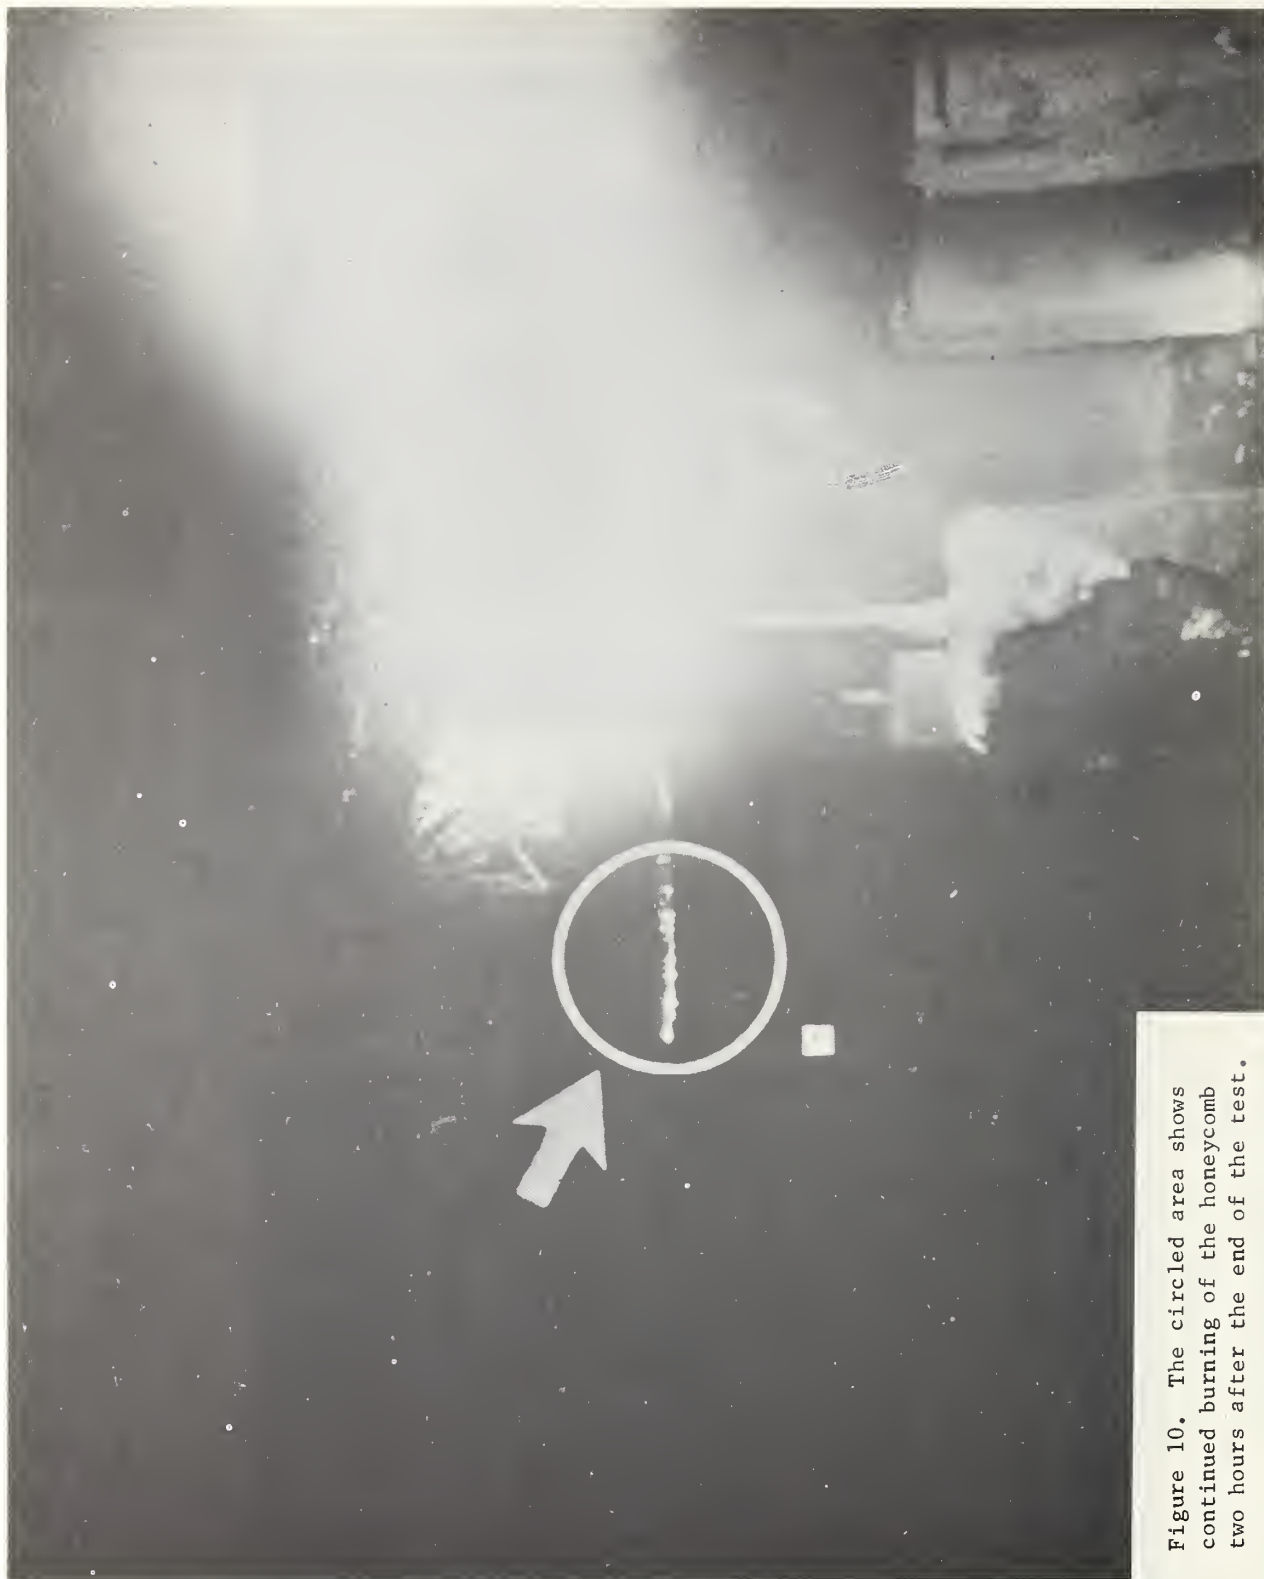
Figure 10. The circled area shows continued burning of the honeycomb two hours after the end of the test.

The flame retardant treatment said to have been applied to the paper honeycomb core apparently did little or nothing to prevent its destruction when exposed to fire. After test, the paper honeycomb core continued to smolder for several hours with occasional eruption into open flaming. Figure 10 shows flaming of the core material two hours after application of a water spray from a fog nozzle at the conclusion of the fire exposure.
